Subj: USS MIAMI (SSN 755) FIRE PANEL RECOMMENDATIONS

**USS MIAMI (SSN 755)
Fire Review Panel**

1 October 2012

2. FIRE OVERVIEW

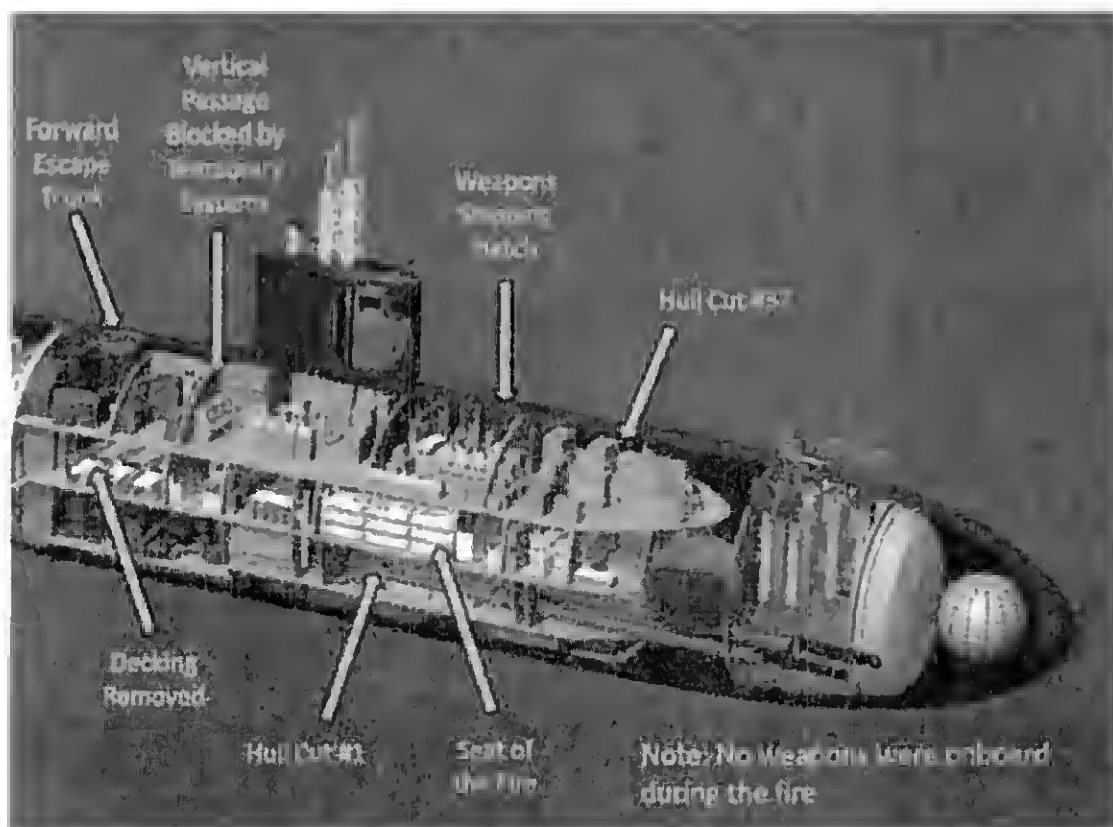
Figure 5: Location of Hull Cuts and Hatches

3.3.1.1. The placement and number of hull cuts can contribute to the severity of a fire. Hull openings from hatches, torpedo tube outer doors, and temporary hull cuts provided a continuous source of air introduction to the MIAMI fire which compounded the effort required to extinguish it. These hull openings had no in-place temporary closure capability which challenged DC teams while fighting the casualty.
